INVESTIGATIVE REPORT MARVIN FIRE

NOVEMBER 12, 2005

VIRGINIA DEPARTMENT OF FORESTRY

INVESTIGATIVE REPORT

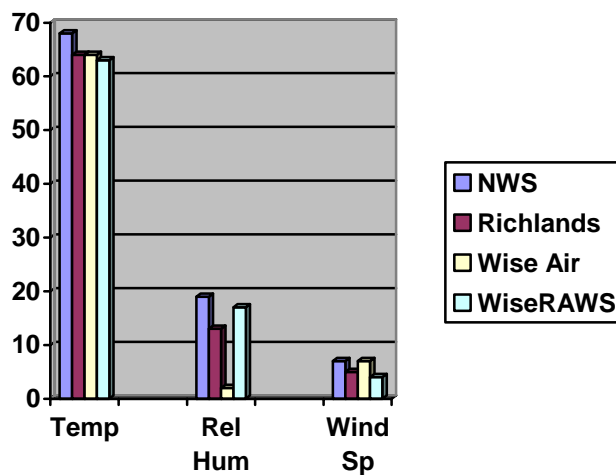
Weather Observations At 1300 11/12/2005

the date in question, they lend credence to the fact that wind apparently played a significant role in contributing to the behavior (rates of spread, growth of fire perimeter, and ground spotting) of the Marvin fire earlier in the day, though perhaps not as much as was evident later in the day. In addition to the wind speeds and direction noted above, two additional factors exacerbated the wind speeds already in evidence at the time of the fire. By late morning (approximately 1000-1100) upslope winds would have started to be present in the area of the fire. The topography of the area was the major contributing factor to these upslope winds. The shape of the land was also a contributing factor. The Marvin Fire was located on the upper section of a large up-valley topographical configuration culminating at the summit of Shortt Gap (figure 4). During the day, especially on days in which differential heating patterns caused by topography and the natural tendencies of warm air to rise are present, up-valley winds are produced which can be expected to reach up to the 10-15 mph range, *not including* wind speeds already present. In addition to the up-valley winds, more topographically specific up-slope winds occur in areas where steep canyons or “hollows” are present. These landforms act as natural funneling agents for warm air that seeks to rise and finds itself channeled between steep slopes on several sides, much in the same way that a chimney creates a draft on a woodstove. Winds produced in this manner can be expected to rise at between 3-8 miles per hour *exclusive* of any other winds already present. At the site where the Marvin Fire started, all three of these factors were present: general winds of 3-7 mph; upslope winds of 3-8; and up-valley winds of 10-15 mph. It is likely that these three winds combined; acting synergistically to create 20-foot winds in the 16-30 miles per hour range at various times during the duration of the fire. Since vegetation can serve as an agent to reduce or even block the effects of wind, especially in areas where large trees and/ or forests predominate, a wind reduction factor should be included as a part of the assessment of winds at the fire scene. The Fire Behavior Prediction System (BEHAVE) used in this analysis provides a wind reduction factor of 0.4 to account for the reduction of wind by standing trees and forested areas. After this computation the final wind speeds at the fire site were likely in the 6-12 mile per hour range, with gusts occurring at twice that rate.

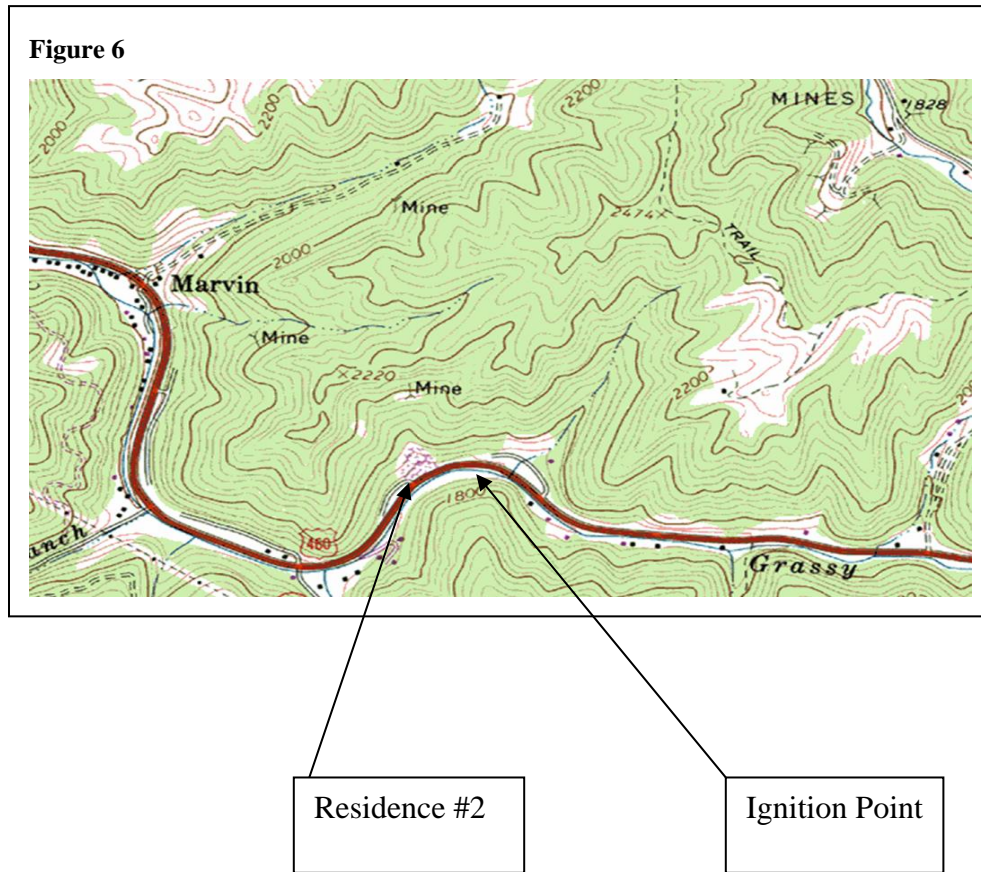
The aspect (the direction that a slope is facing) of the Marvin Fire also contributed significantly to fire behavior by providing opportunities whereby fuels received more direct heating (from the sun), and therefore possessed lower fuel moistures (caused by lower humidity and higher temperatures) than in other areas. The south and southeast aspects of the Marvin Fire assessment provided those aspect conditions considered to be most favorable for fire start and spread.
